APPLICATION NOTES

IMPACT Solutions for Automotive Industry Aluminum Wheel Inspection

IMPACT Cameras Verify Aluminum Wheel Model Types

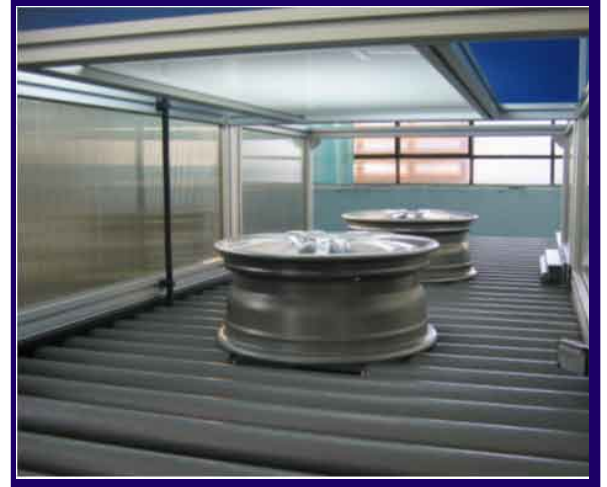
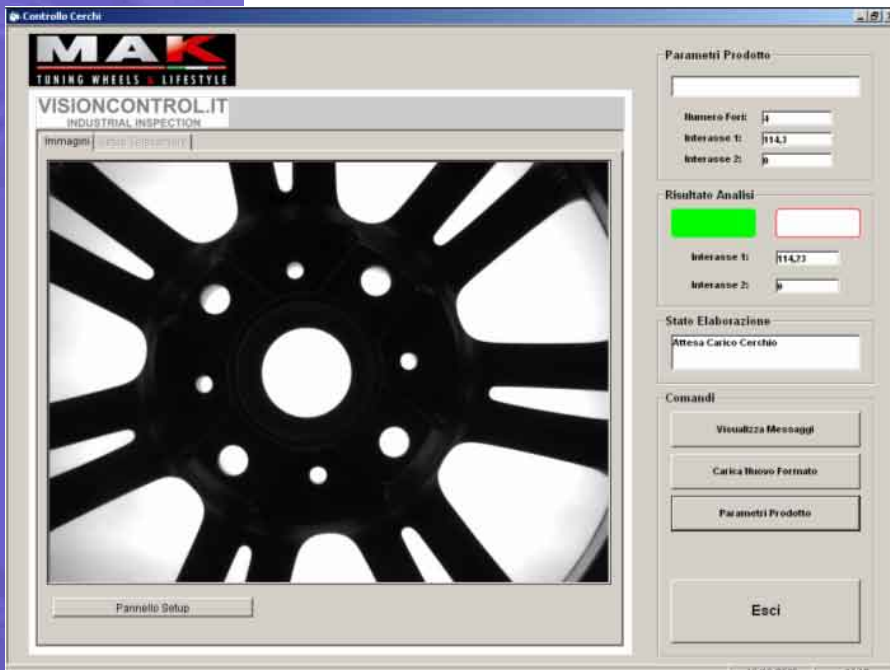
The two IMPACT cameras are mounted on a multi-axis motion controlled fixture located below the roller conveyor. As the wheel enters the camera FOV, the first IMPACT camera takes a picture and calculates the coordinates of the bolt holes. These coordinates are sent to the motion control PC so it can move the second IMPACT camera and position it to view each of the bolt holes individually. This second IMPACT camera has a FOV of 30 mm by 20mm. The camera measures the center of the hole, then moves to the next hole and measure the next center point. This process is repeated until all holes are measured. The center points are then fed into the Fitted Circle composite tools, where a best fit circle is generated. The diameter of the fitted circle is used to determine the wheel model.
